DECISION NOTICE ADOPTION OF EXISTING ENVIRONMENTAL REVIEW

Central Post and Treating Company CECRA Facility: Phase II, Capping and Site Reclamation
September 2022
City of Lewistown
47.076771, -107.406673
Fergus County

Existing Environmental Review Document: Tetra Tech Voluntary Clean Up Plan for Montana
Department of Environmental Quality – Environmental Assessment

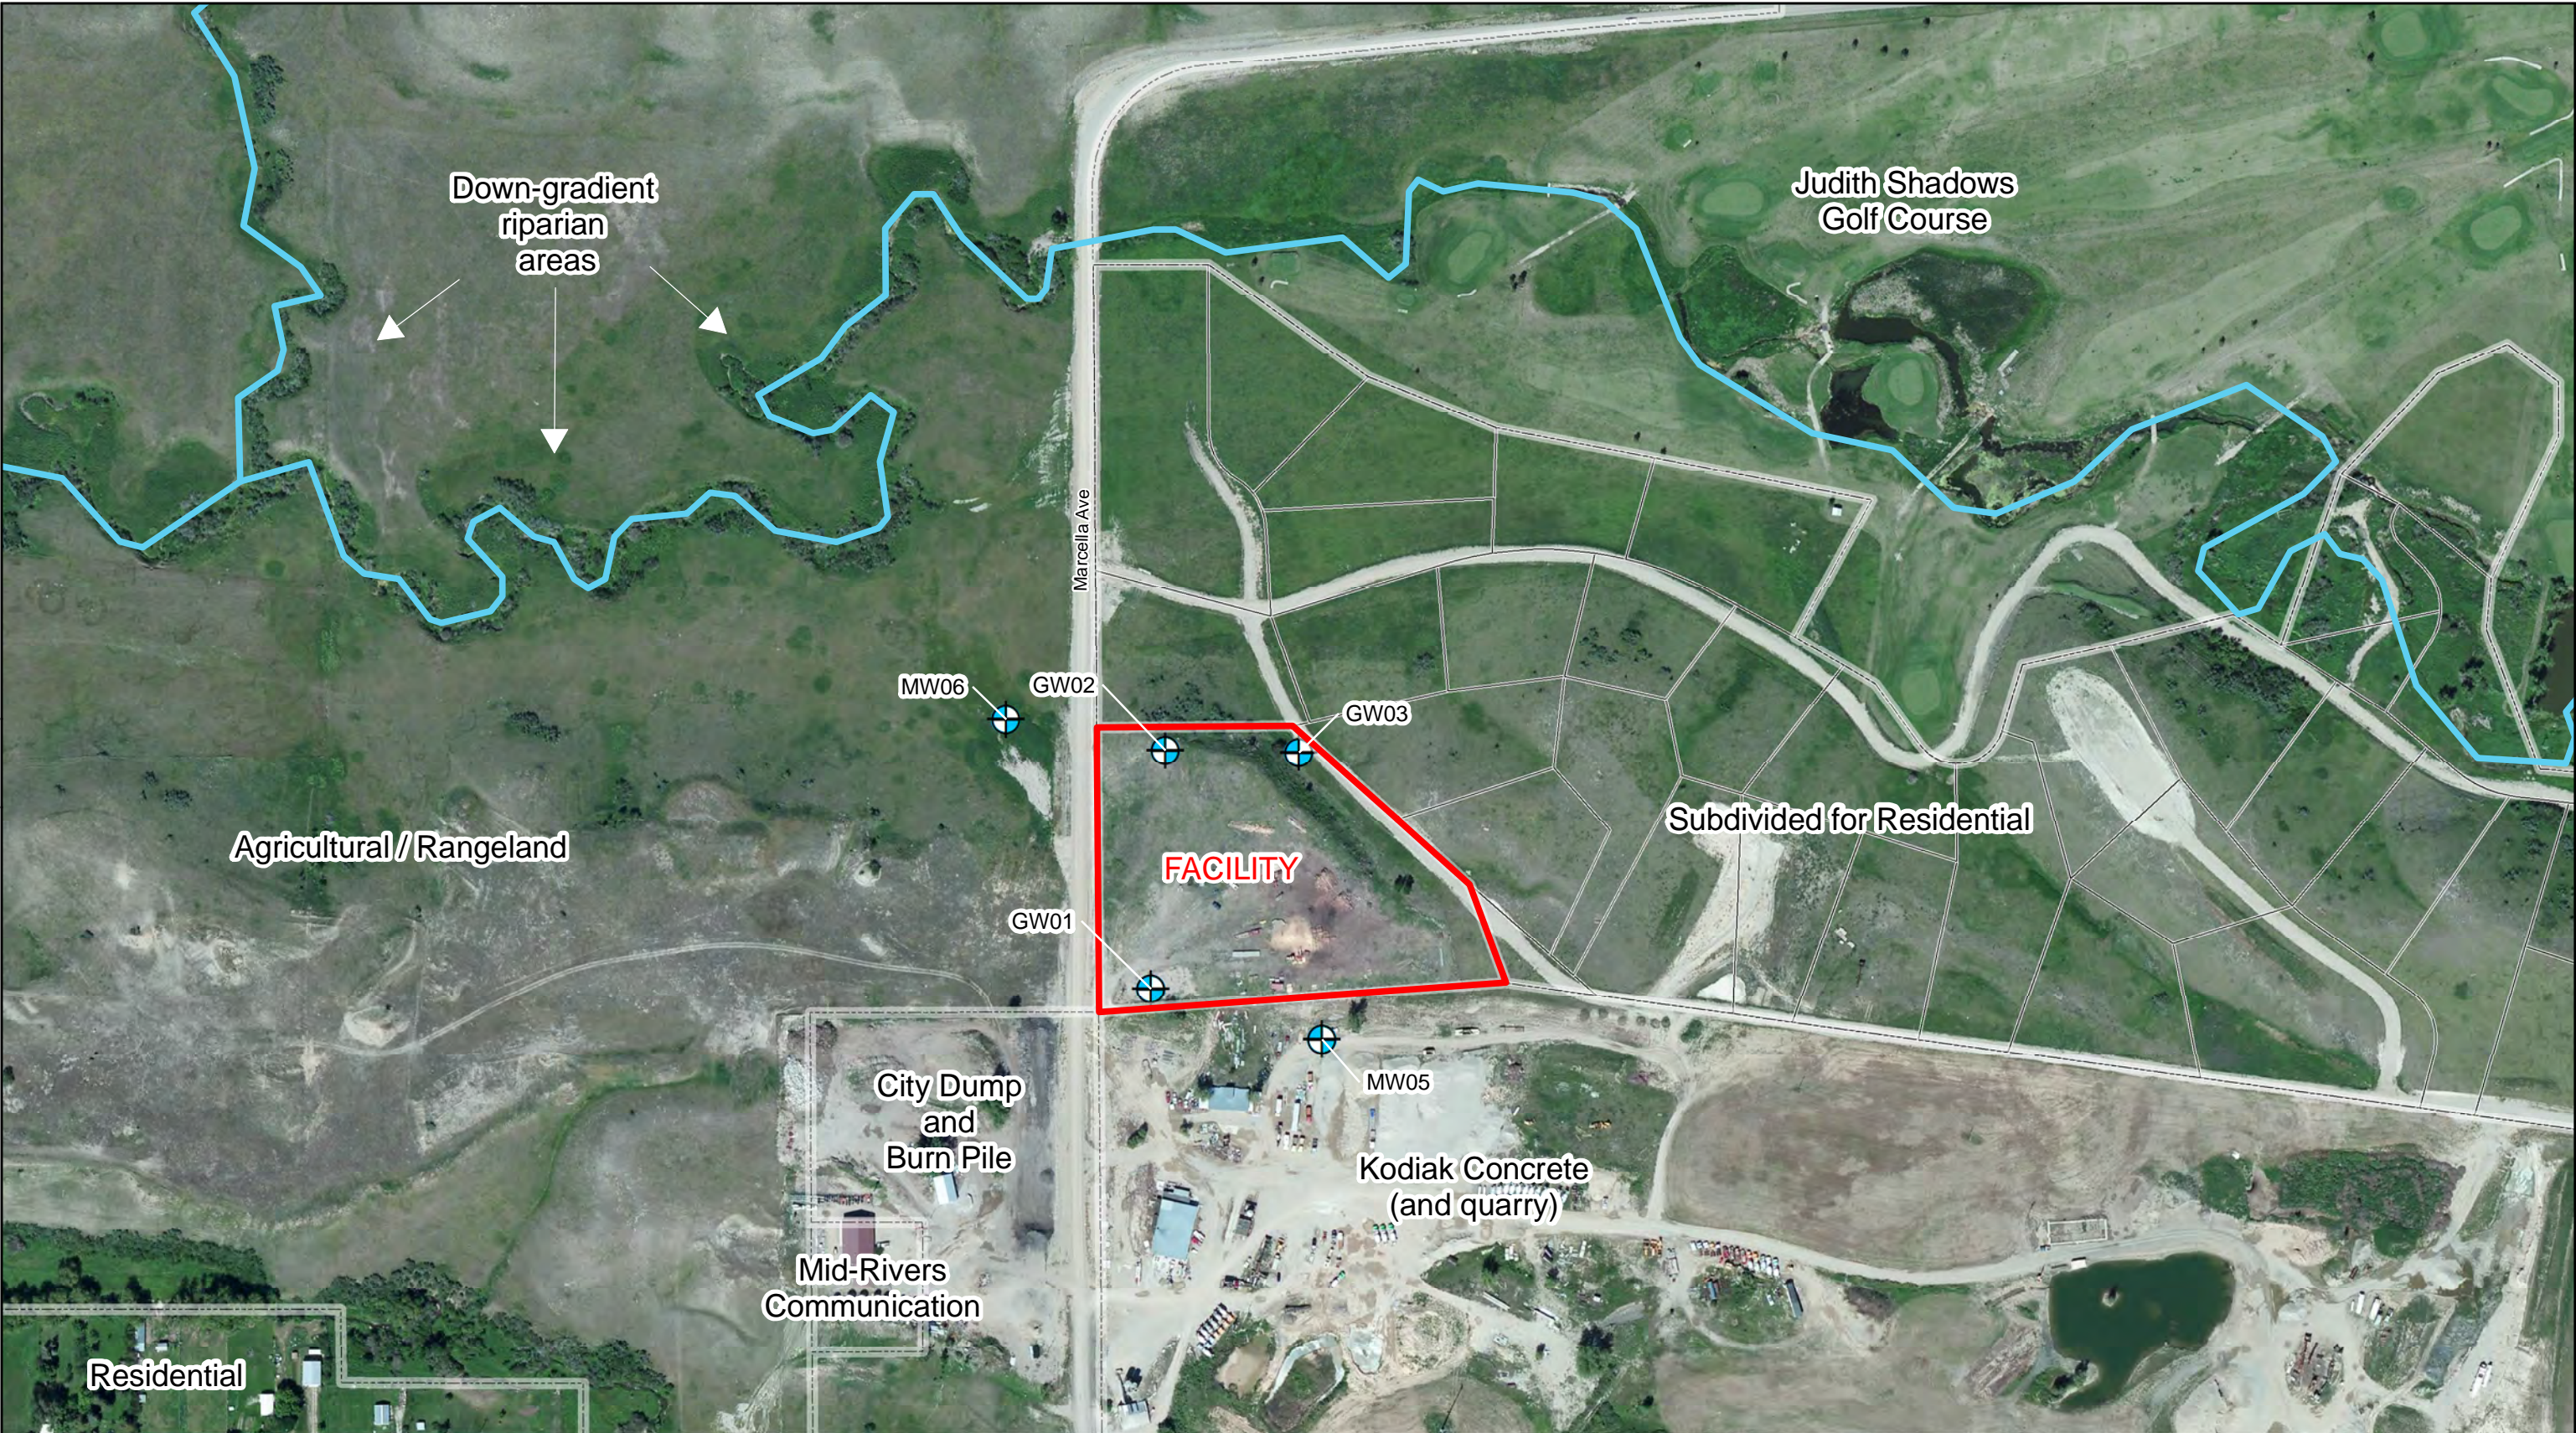
Central Post and Treating Company CECRA Facility
FIGURE 2 FACILITY MAP
TETRA TECH

Adjoined properties have multiple land uses (**Figure 2, Appendix A**). The property to the north and east of the Facility (Shadows Estates) was recently sub-divided into 1-acre residential parcels that have yet to be developed. Property to the west of the Facility (across Marcella Avenue) is owned by the Weeden Ranch and is used as agricultural rangeland. The City of Lewiston operates a “green” waste facility and burn pile for tree and yard debris to the southwest. Kodiak Concrete operates a concrete and quarry operation to the south. Breed Creek is located 540 feet northwest of the Facility, and is bordered by a small riparian areas. Additionally, there is a small commercial telecommunications office located 500 southwest of the Facility (Mid-Rivers Communication).

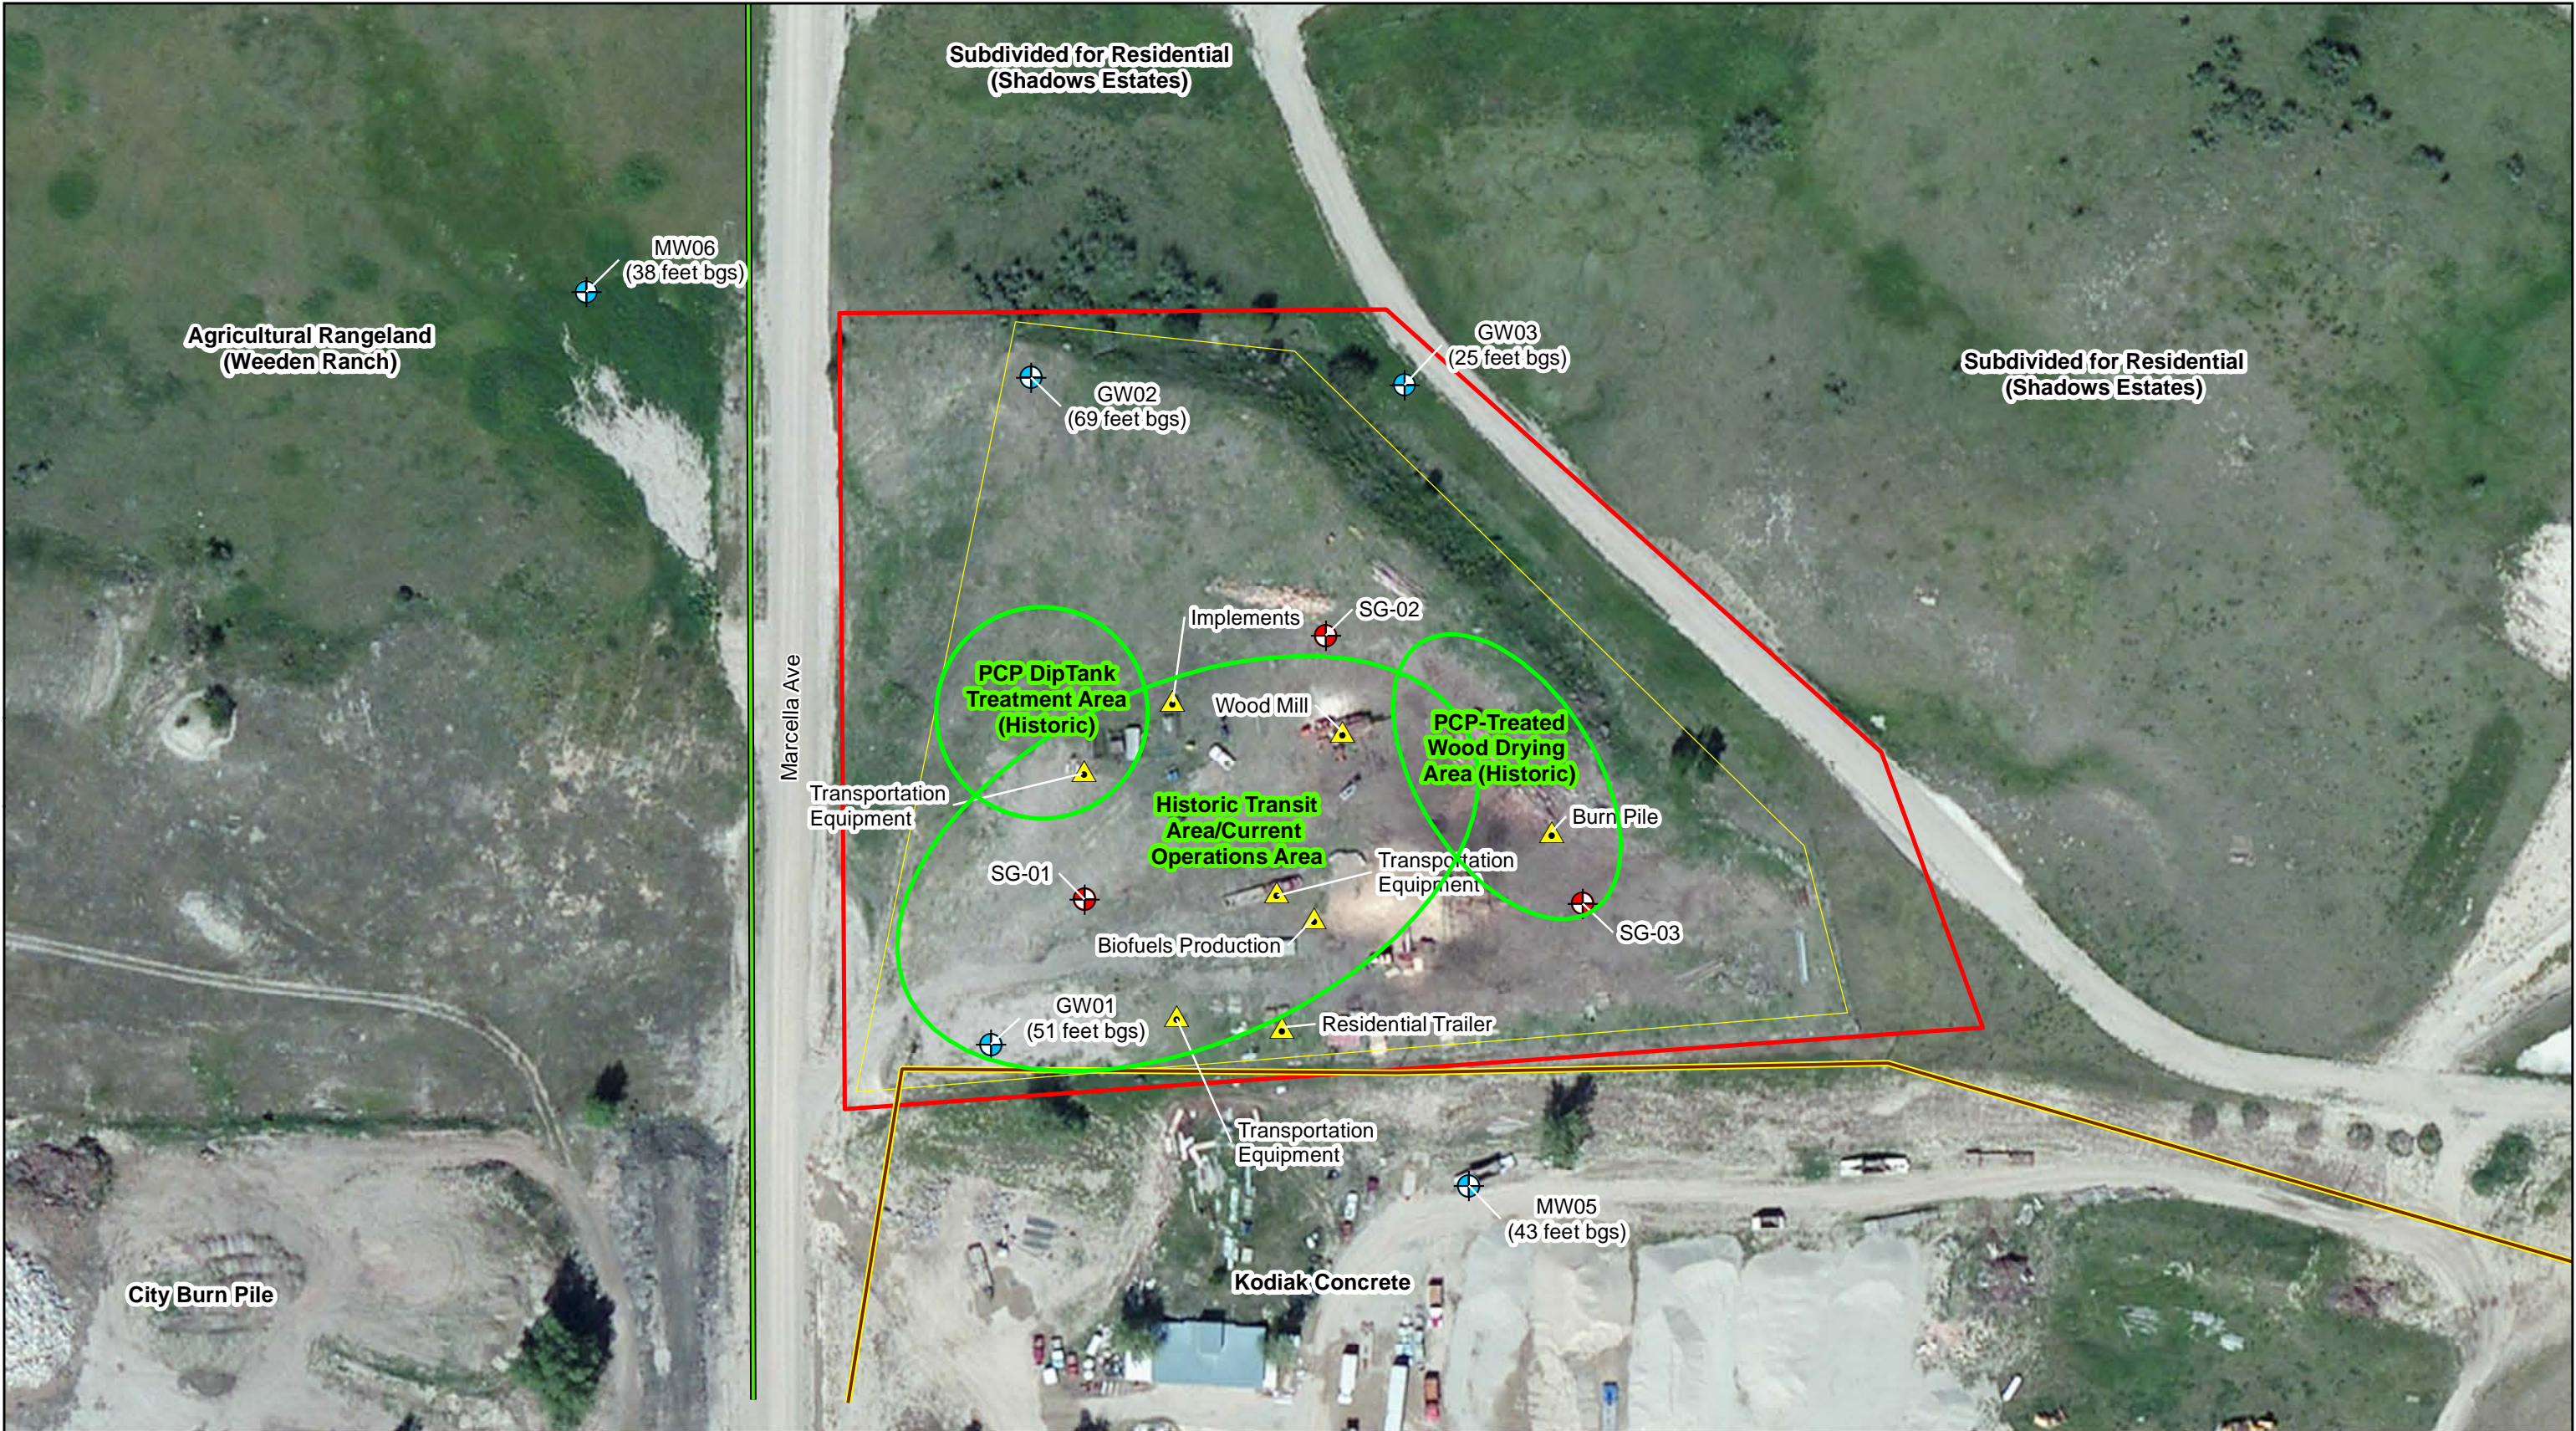
FIGURE 3
DETAILED FACILITY MAP

LEGEND			
	Methane Soil Vapor Monitoring		Site Feature
	Monitoring Well		Buried Telco Line
			Aboveground Power Line
			Landfill Extent
			Property Boundary
			bgs Below Ground Surface
			PCP Pentachlorophenol

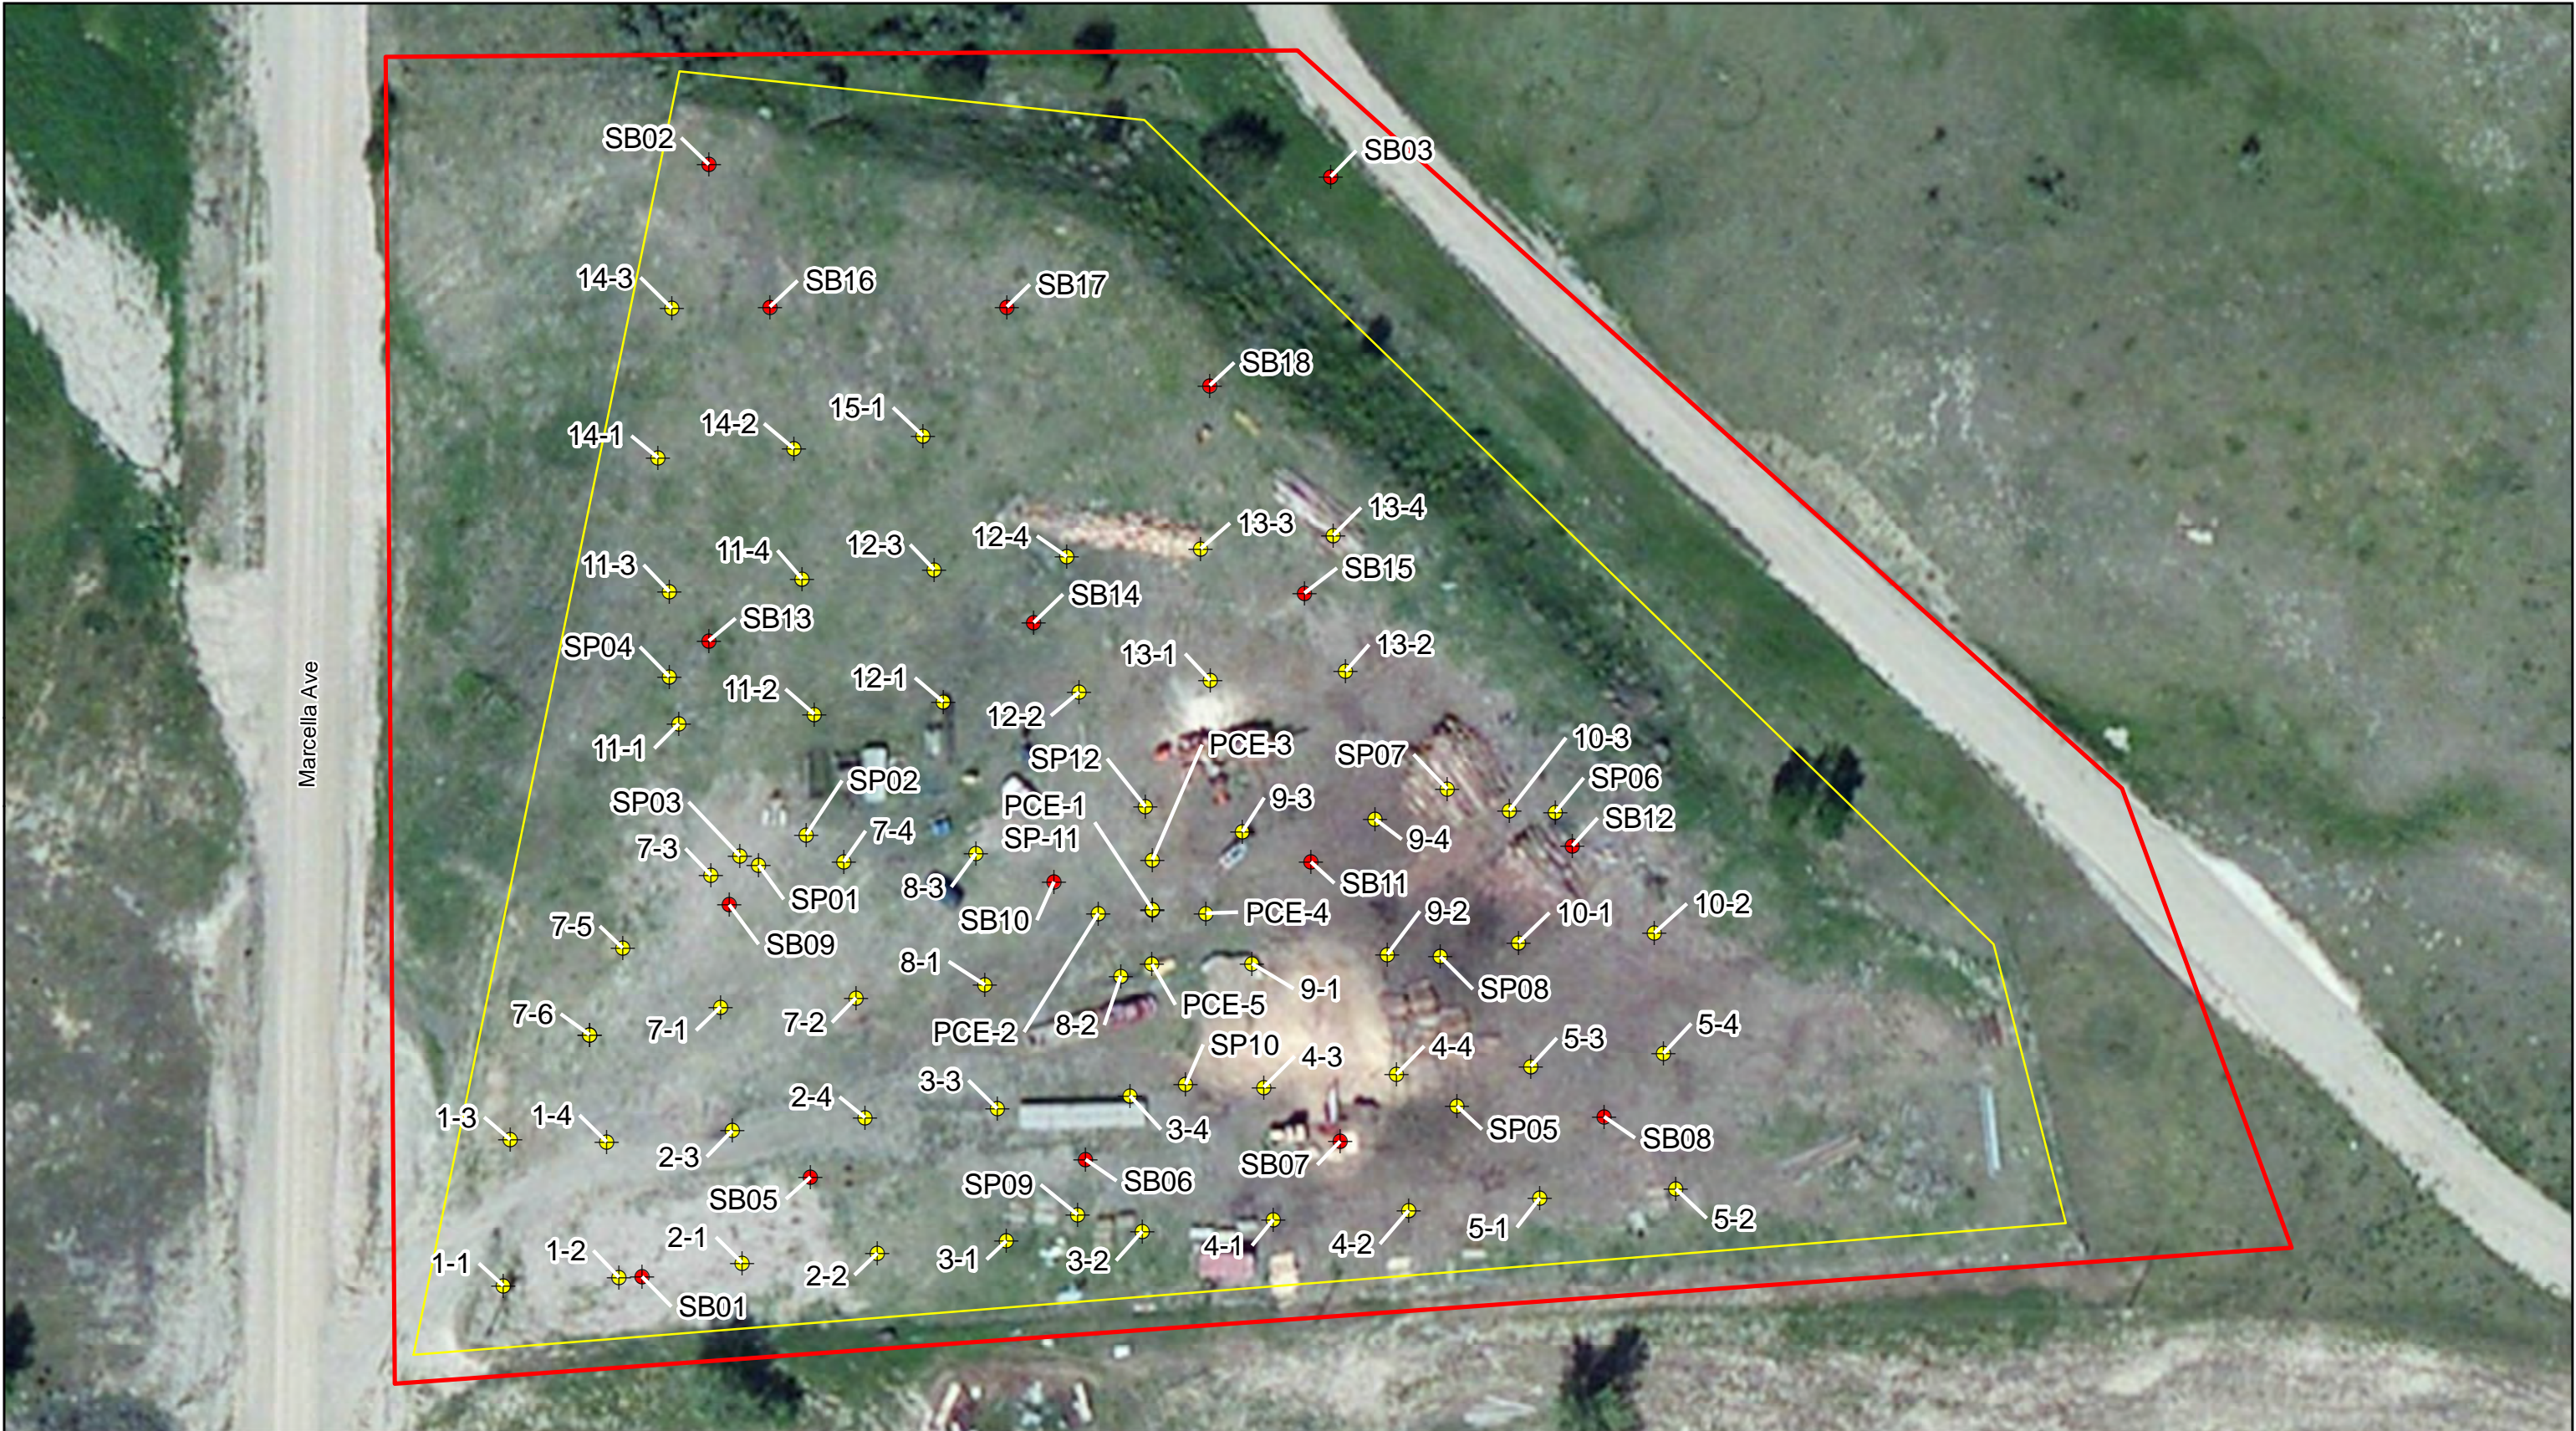
Figure 10: Soil Sampling - SLM - 4/21/2017

- Soil Excavation Pit
- Landfill Extent
- Soil Boring
- Property Boundary

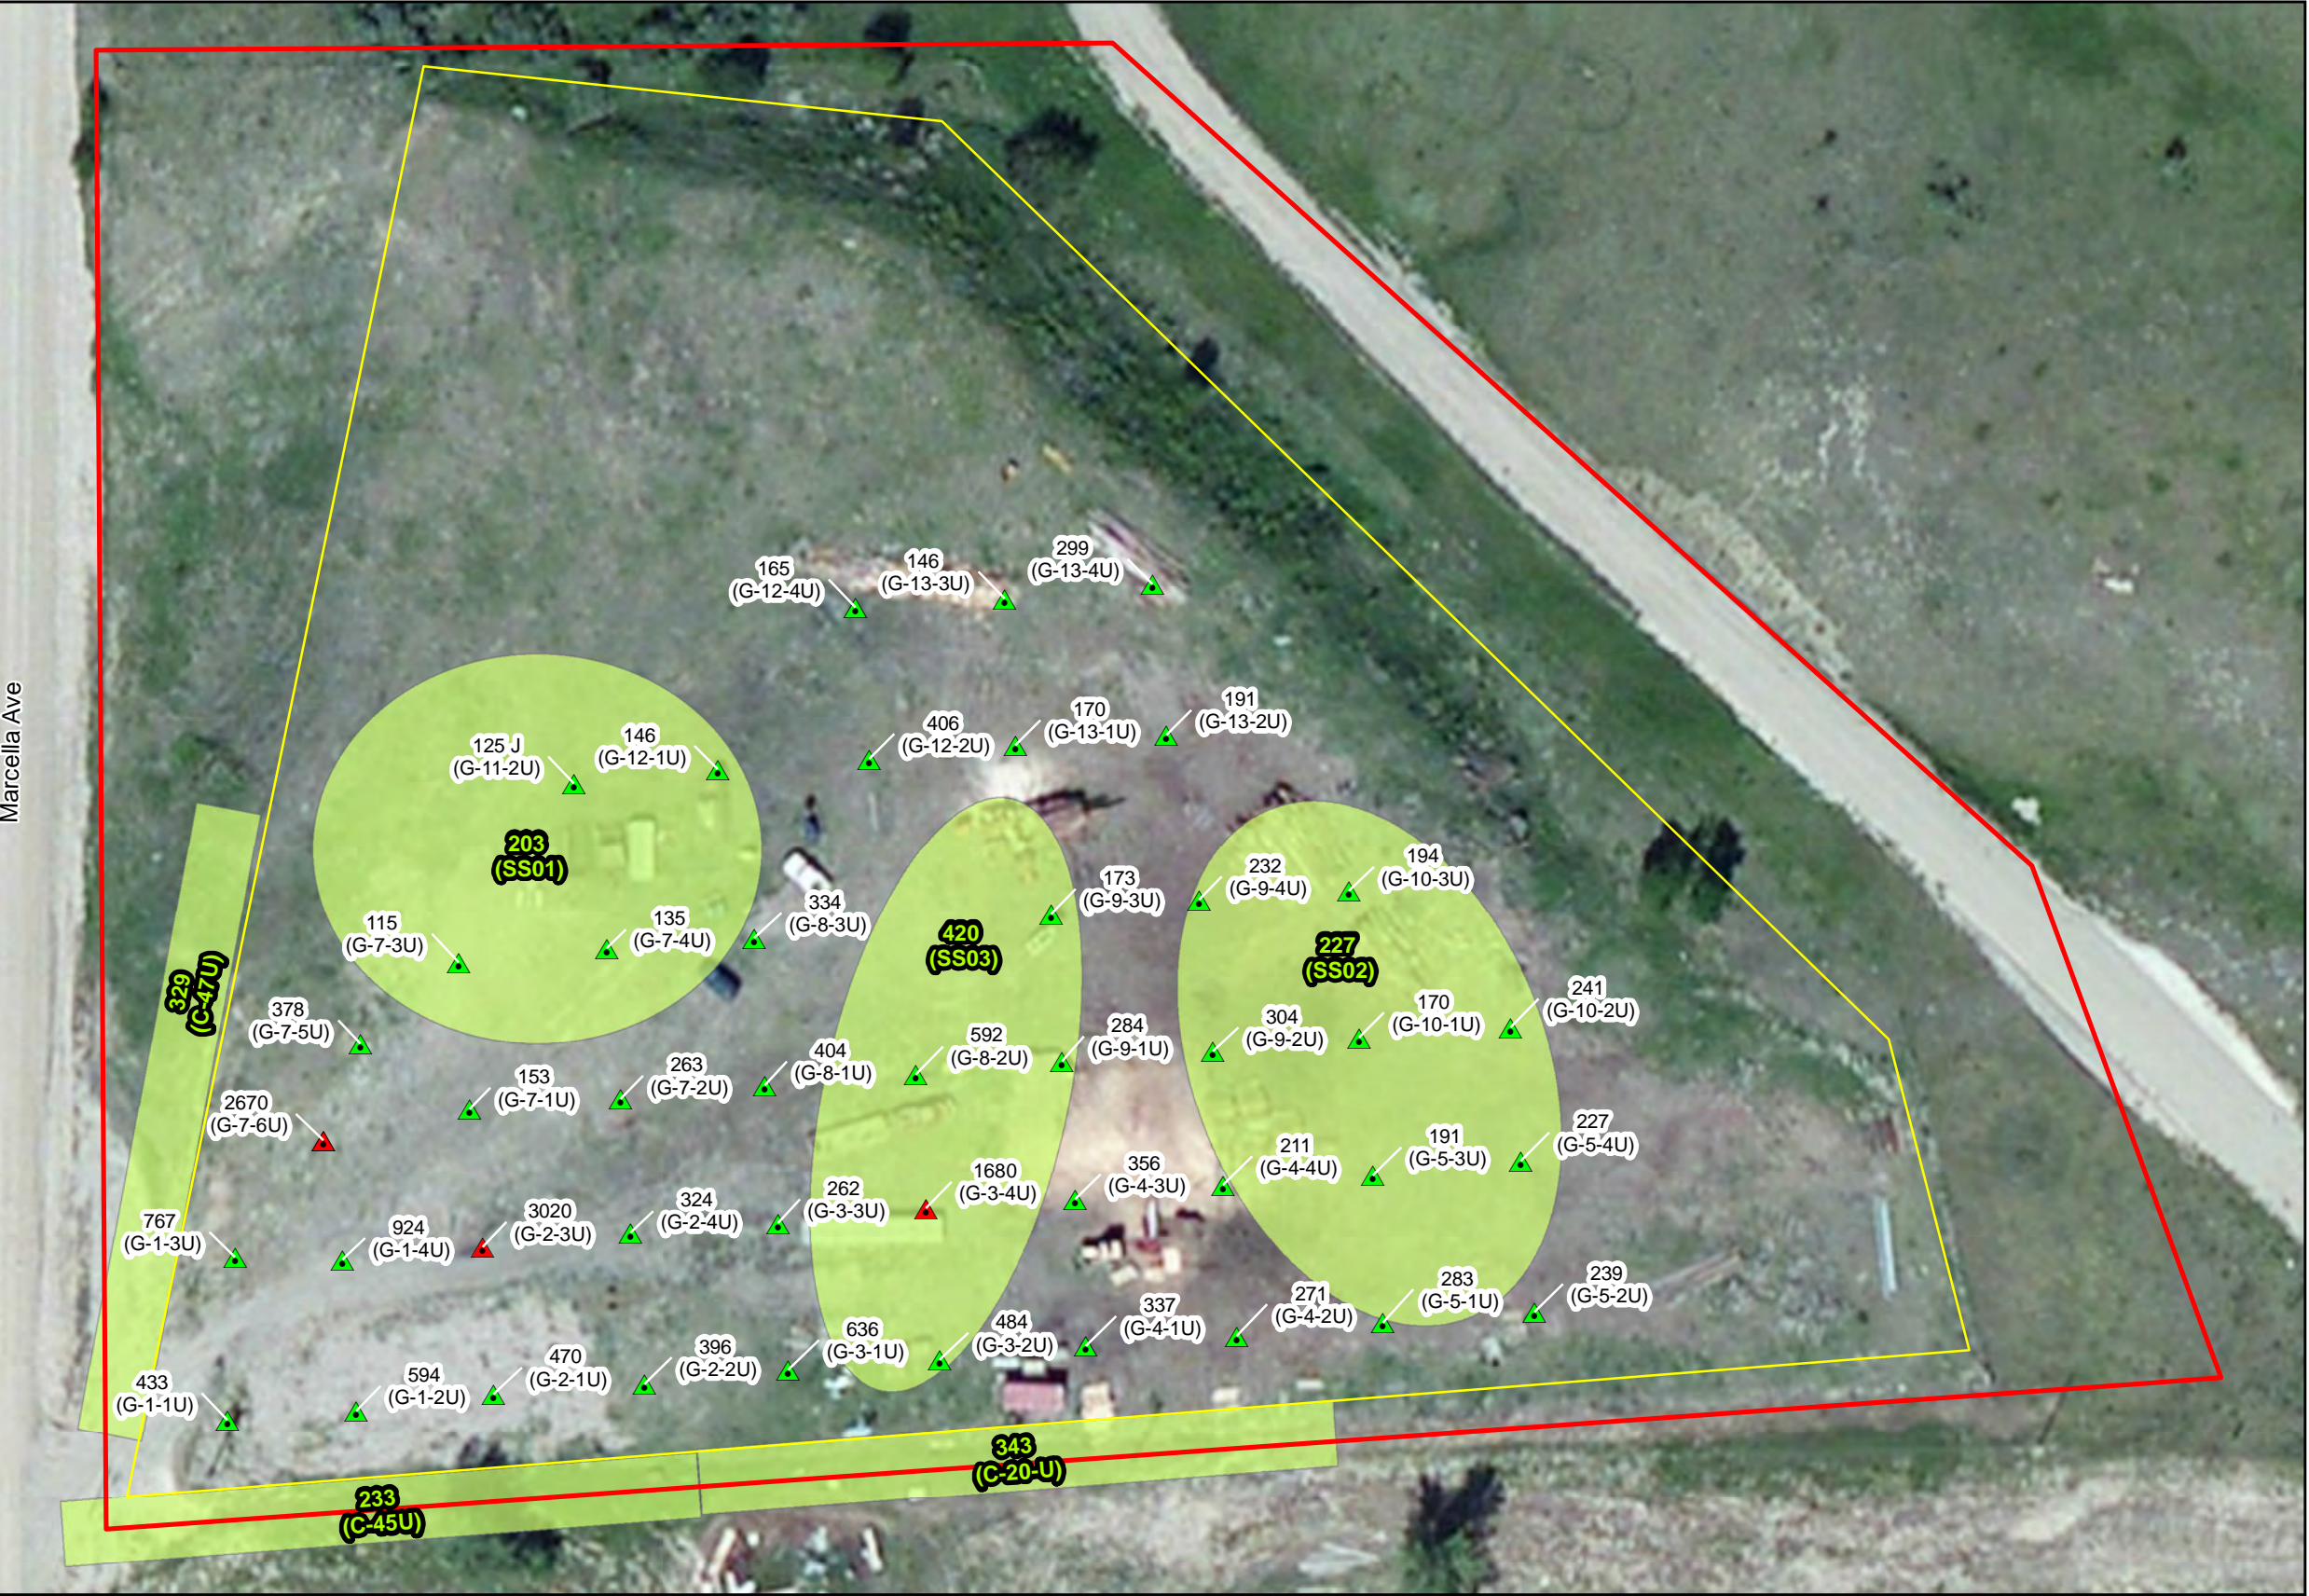
Screening Levels (mg/kg)	
Residential DC:	1500
Industrial DC:	22000
Construction DC:	152186
Generic PGW:	1600
Site Specific PGW:	22000
BTV:	429
BTV: Background threshold value	
DC: Direct contact	
PGW: Protection of groundwater

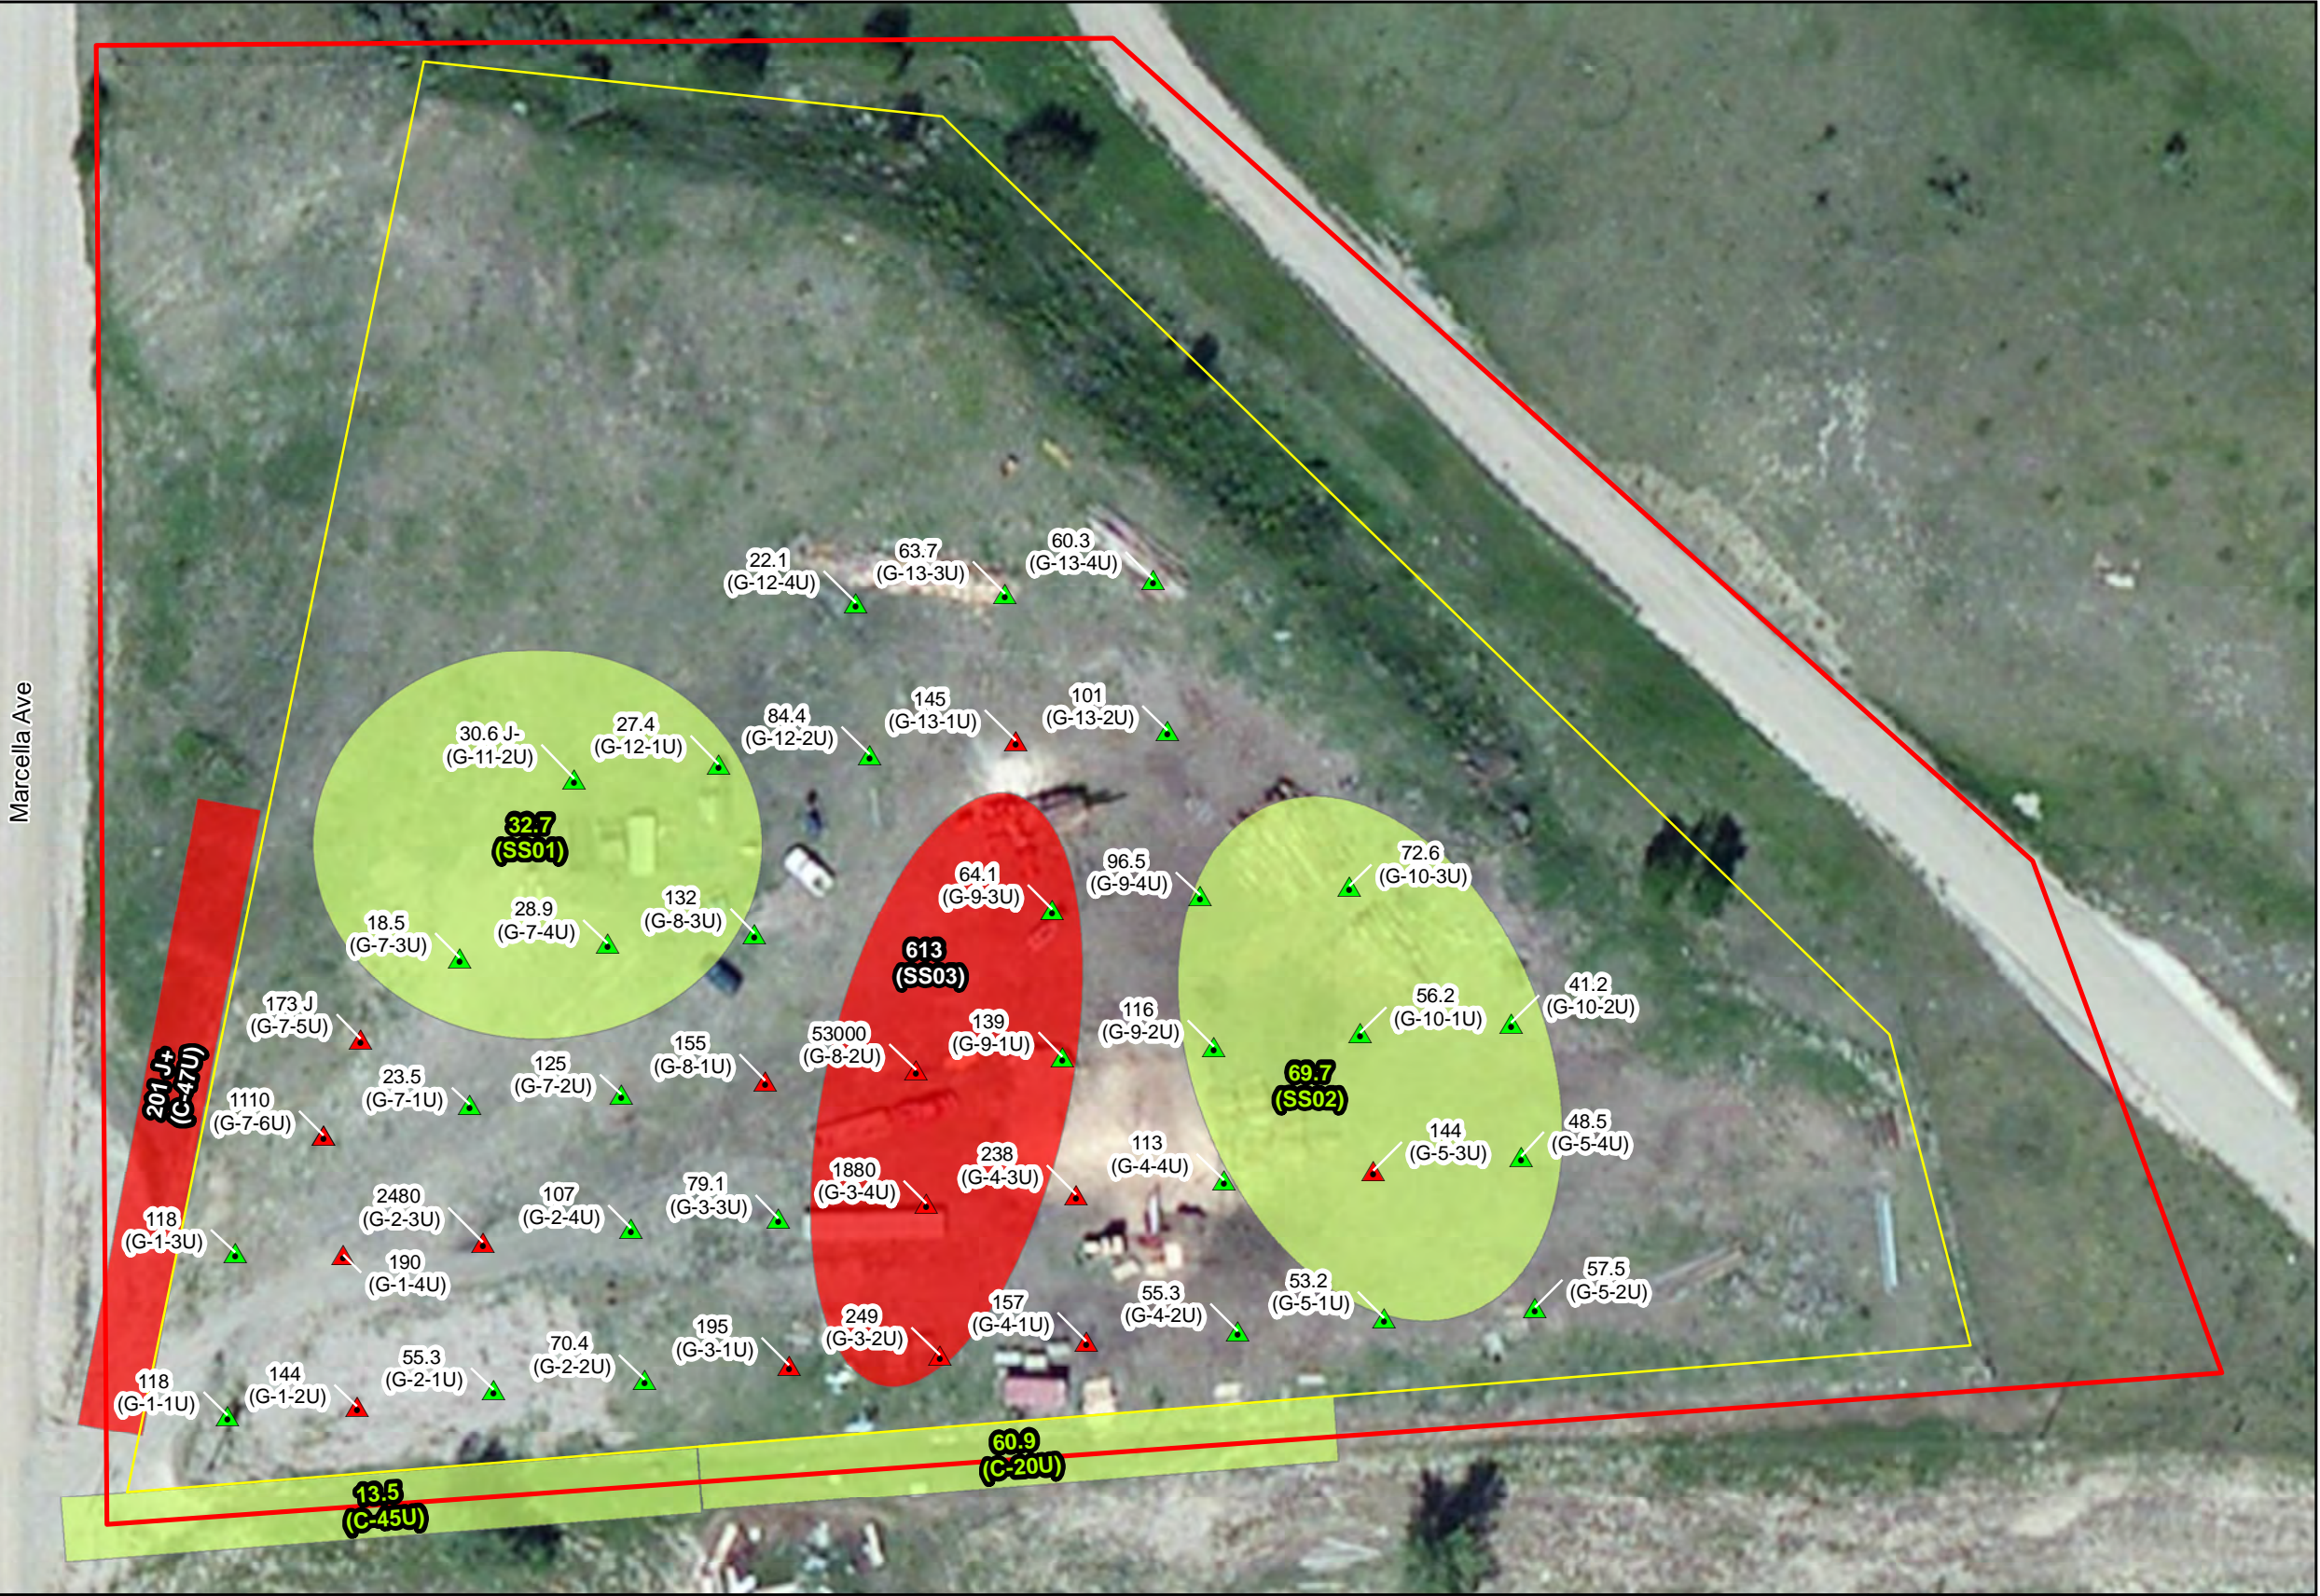
Screening Levels (mg/kg)	
Residential DC:	153
Industrial DC:	679
Construction DC:	153
Generic PGW:	140
Site Specific PGW:	478
BTV:	29.8
BTV: Background threshold value	
DC: Direct contact	
PGW: Protection of groundwater

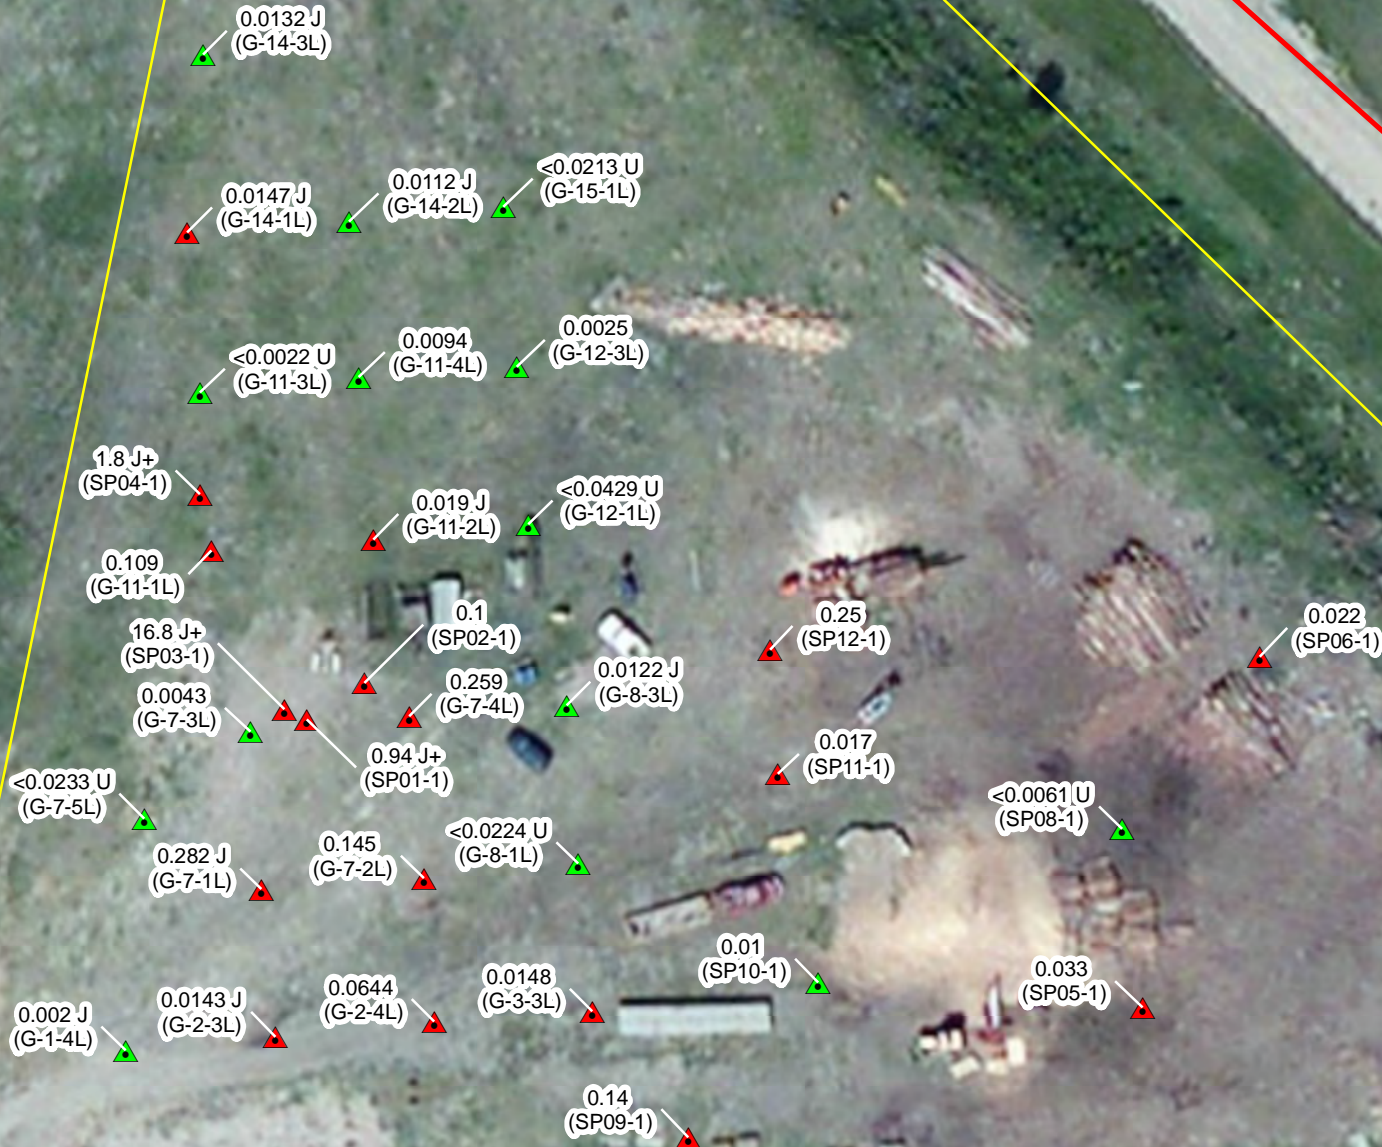
FIGURE 23
PENTACHLOROPHENOL (1 - 2 FEET)
SURFACE SOILS

Screening Levels (mg/kg)	
Residential DC:	1
Industrial DC:	4
Construction DC:	77
Generic PGW:	0.014
Site Specific PGW:	3.56
BTV: Background threshold value	
DC: Direct contact	
PGW: Protection of groundwater

LEGEND	
Soil Sample (Results in mg/kg)	
▲ Result less than generic PGW screening level	Landfill Extent
▲ Result greater than generic PGW screening level	Property Boundary
	(G-2-3L) Sample ID
	J Value is an estimate
	mg/kg Milligrams per kilogram
	PGW Protection of groundwater
	U Constituent is considered not detected
	< Constituent was not detected at or above the laboratory practical quantitation limit
